Service Bulletin: TSB-012

System: Chassis/Suspension

The intent of this bulletin is to request an additional inspection during Pre-Delivery Inspection (PDI) or at the 2500-mile interval to ensure durability and performance. Please inspect the installation of the steering gear outer tie rod on the Mullen THREE.

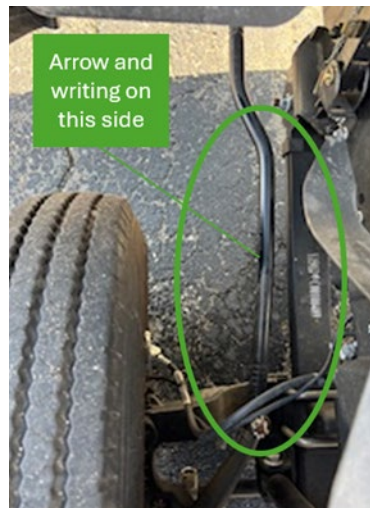
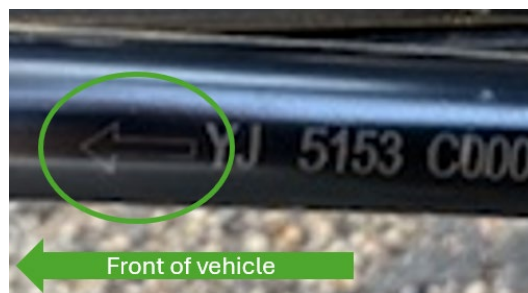
Outer Tie Rod installed with orientation arrow to front of vehicle

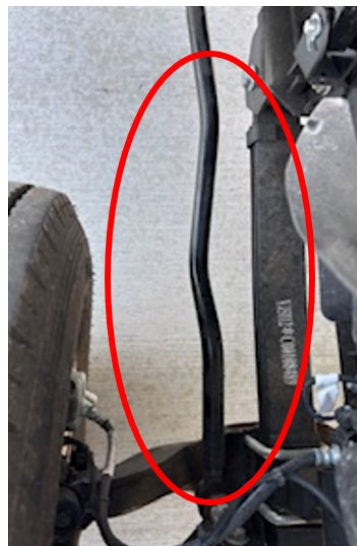
Outer Tie Rod installed with orientation arrow installed to rear of vehicle

3. If tie rod orientation is rearward, proceed with the reinstallation procedure.
