Service Bulletin: TSB-012

System: Chassis/Suspension

The intent of this bulletin is to request an additional inspection during Pre-Delivery Inspection (PDI) or at the 2500-mile interval to ensure durability and performance. Please inspect the installation of the steering gear outer tie rod on the Mullen THREE.

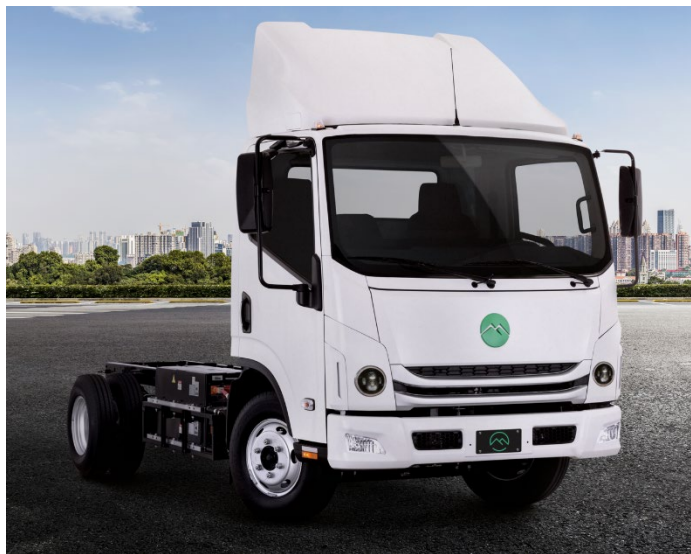
Mullen Automotive is sharing its procedure for inspecting the orientation of the steering gear outer tie rod of the Mullen THREE. The tie rod has an orientation arrow that is to be pointing towards the front of the vehicle. If not, please follow the reinstallation procedure.
